Saxilby with Ingleby Parish Council

Summary of Structural and Roofing Survey Report

The structural (including roofing) survey of St. Andrews Community Centre, Saxilby, LNI 2LP was carried out on 30 Oct 2024. It identified a number of key findings and recommendations:

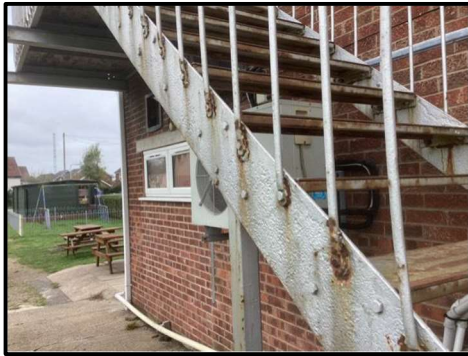
Figure 1: Right Hand Fire Escape

The steel-framed right-hand fire escape structure shows rust and degradation, especially the staircase, which is considered hazardous. Whilst the staircase is repairable, it is recommended that specialist contractors are appointed to assess for repair and if not reasonable, then replacement of the structure will be necessary.

It should be considered for replacement to ensure it is safe for future use and a low liability risk (p.9)

- **Cost: £10,000+**
- **Timeline:** No specific timeline – specialist contractor to advise
- *Note: Estimate excludes removal and disposal of existing unit and a risk assessment to determine if the building can be in use during periods of work should also be factored as this could affect revenue or insurance.*
- **Purpose:** To address the degraded right-hand fire escape, including removal and disposal of the current structure.

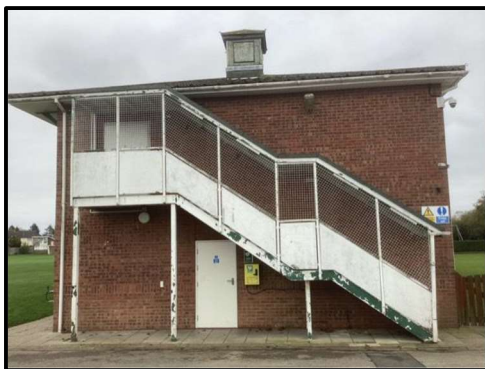
Figure 2: Left-hand Fire Escape

The roof over the left-hand fire escape is severely degraded, posing a safety risk and needs replacing. The surface covering and decking material should be replaced.

- **Cost:** Not specifically estimated but involves replacing the mineral felt roof surface and underlying timber.
