# Building Survey

**Client Name:** Saxilby Community Parish Council  
**Address:** St. Andrews Community Centre  
William Street  
Saxilby  
Lincolnshire  
LN1 2LP  
**Purpose of Report:** STRUCTURAL BUILDING SURVEY  
**Report Reference:** SBS|MLH|2024  
**Inspection Date:** 30 Oct 2024  
**Surveyor Name:** C McLean BSc Hons, MCIQB, CSRT, CSSW, DipDEA, UKAS-P402/P405  
**Building Surveyor Engineer Name:** Greg Owen BSc (Hons) C Build E, MCABE.

**Type of property:** Community centre

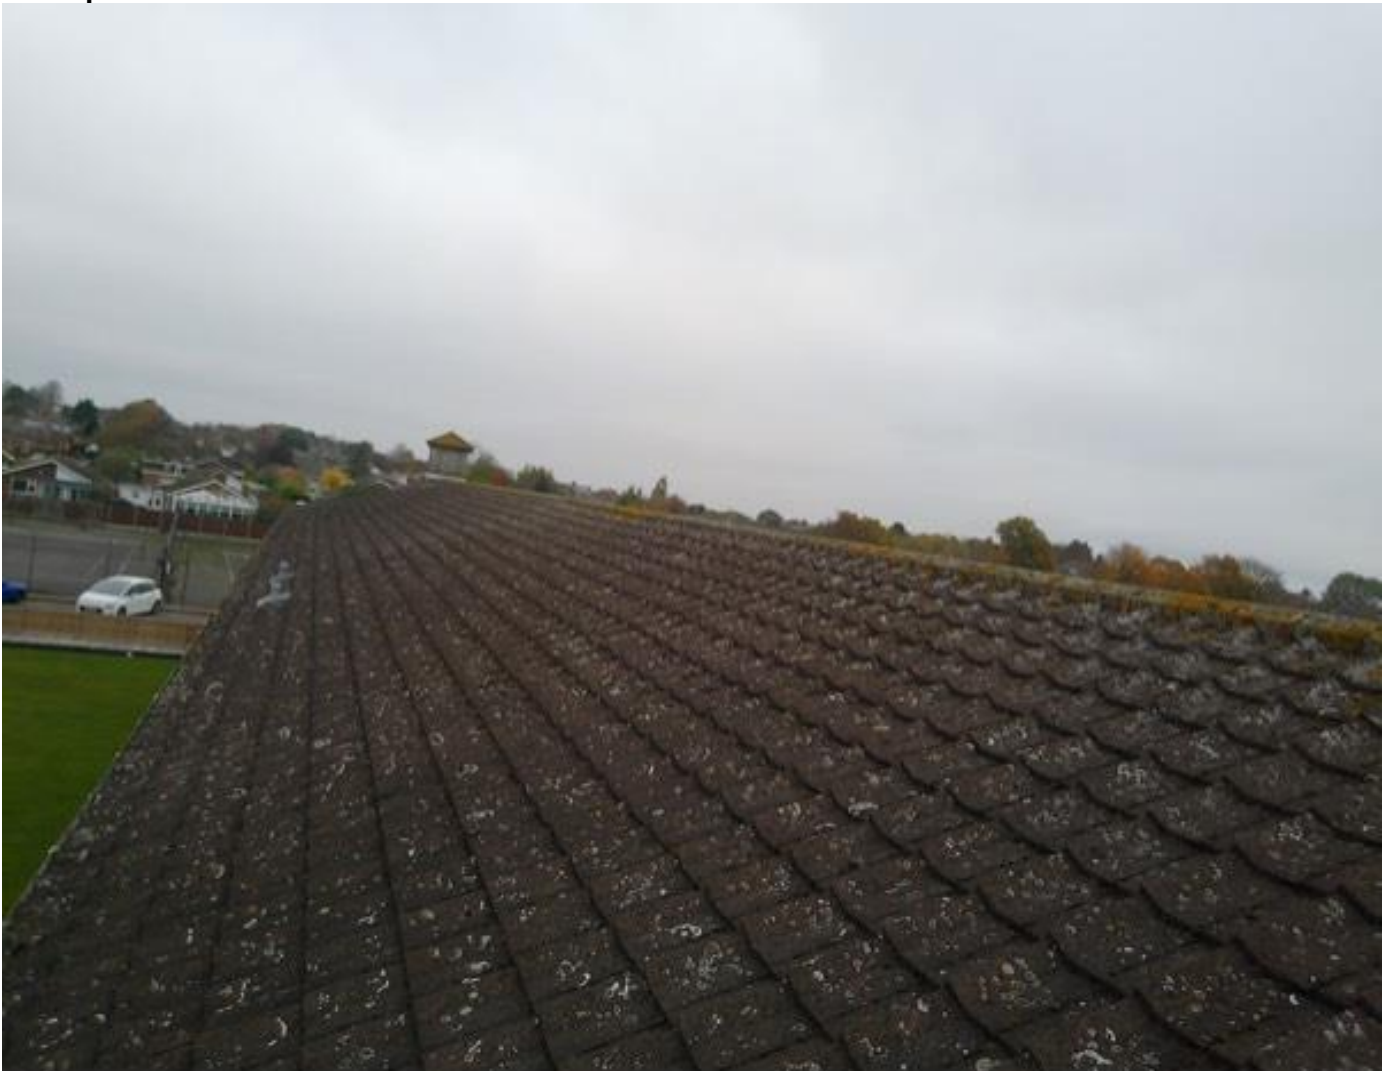
## Front pitch

- The property has a pitched tile roof (Concrete tiles) this appears to be in good condition but requires maintenance to the mortar areas.
- The mortar verges require maintenance where cracking/missing mortar is evident and common problem with exposed gable edges.

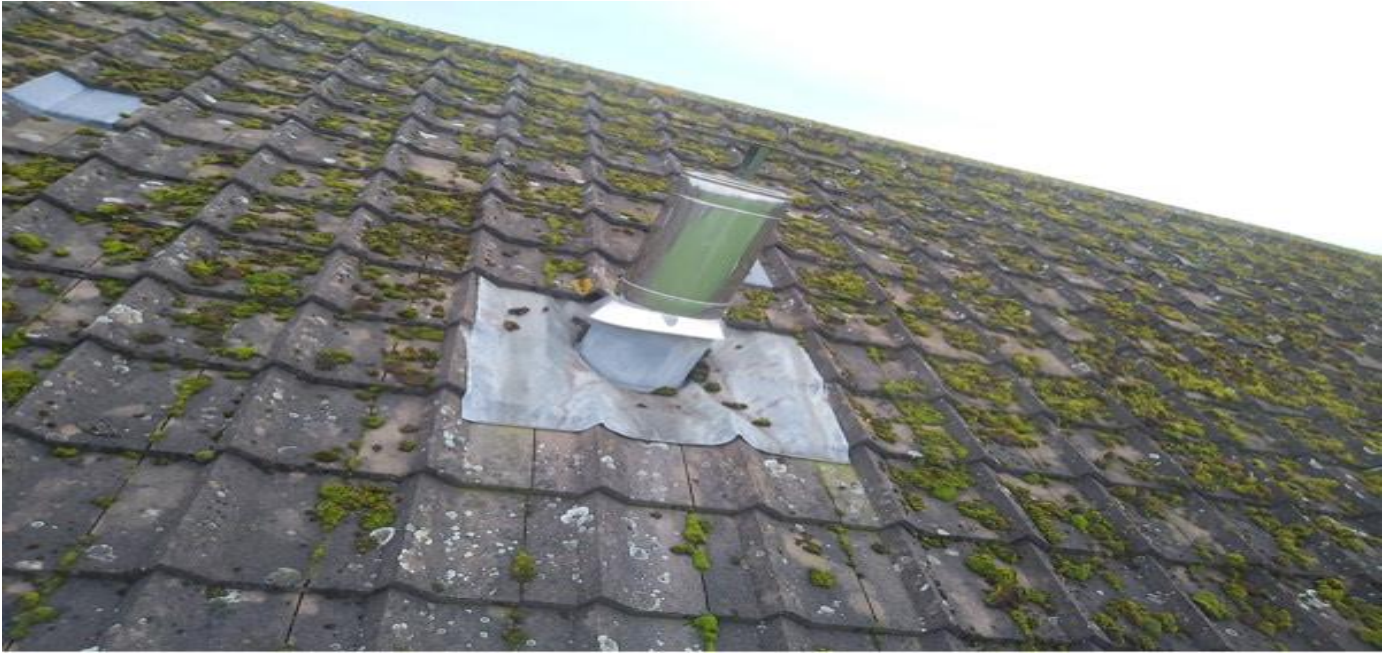
## Disused boiler flue

- There is a disused boiler flue installed at rear pitch of roof, double lined stainless-steel flue with flashing kit fitted at roof surface.
- Recommend this is removed and the roof surface tiled to reduce the risk of water ingress.

- The disused flue pipe from the former boiler system is an ingress risk into the roof and ceiling areas of the property, recommend this is removed and the roof surface retiled.

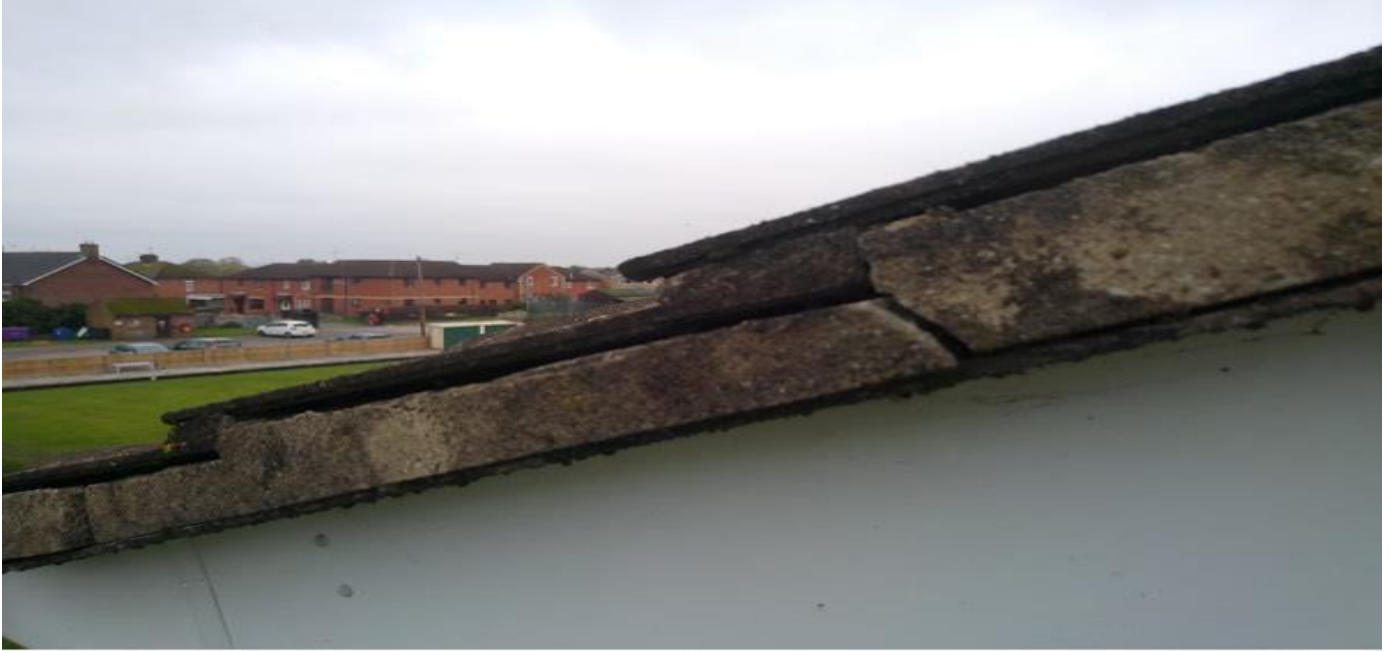
- The gable verge overhang at the right-hand gable end of the building is degraded, with loose mortar present, this bonded surface is in place to prevent water ingress and wind lifting of the tiles fitted to the verge, so loose mortar is a fall hazard along with potential damage to roof surfaces during storm conditions.
- The verge should be accessed and repointed to prevent loss.

**Mortared verge overhang is degraded**

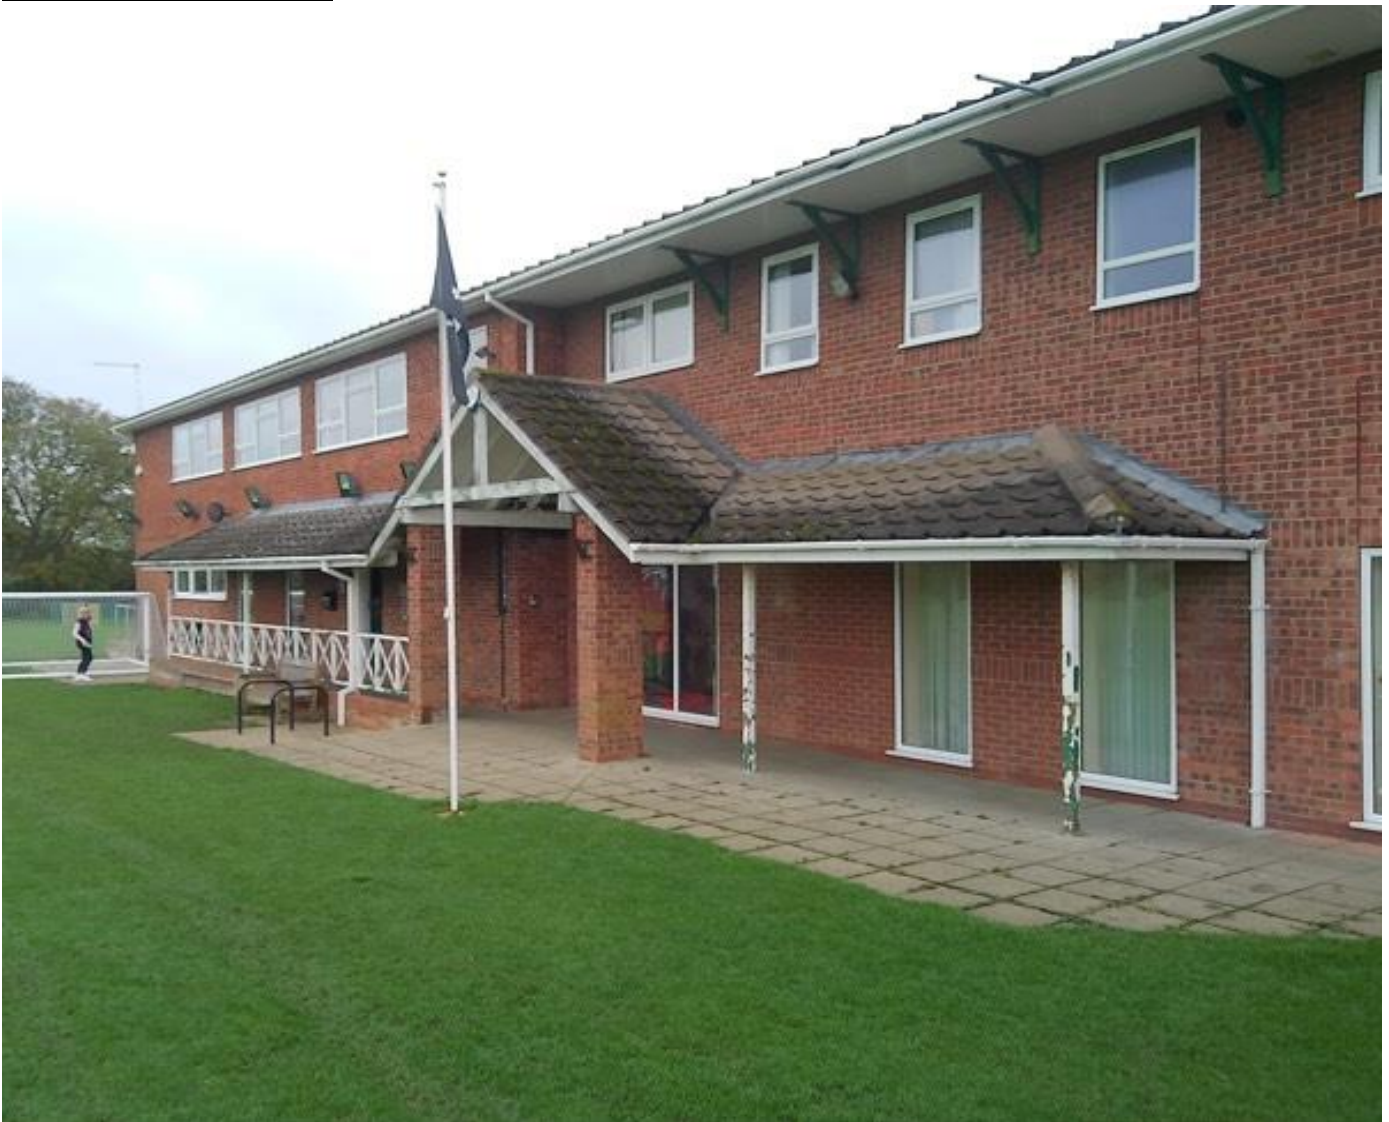
## Main entrance roof area

- The property has a pitched tile roof (Concrete tiles) this appears to be in good condition generally but does have a small number of broken tiles and failed lead flashing at the boundary with the main elevation and the valley areas require maintenance.
- The tiles require repair where cracked tiles and missing mortar is evident

- With these defects to consider and the lack of availability for the existing roof tiles, it is recommended that the tiled surface of the entrance cover be removed and the tiles placed in storage. These could then be utilised to repair the main roof surfaces as necessary (such as to recover the area of the disused flue pipe).

- The porch area can then be resurfaced with modern concrete interlocking tiles which are easily matched and available (Marley Modern Tiles for example) The roof surface of the building will likely require resurfacing in full within the next 10-15 years, by holding tiles from the lower roof area to carry out repairs in the intervening period would help to prolong the life of the roof and reduce material costs.

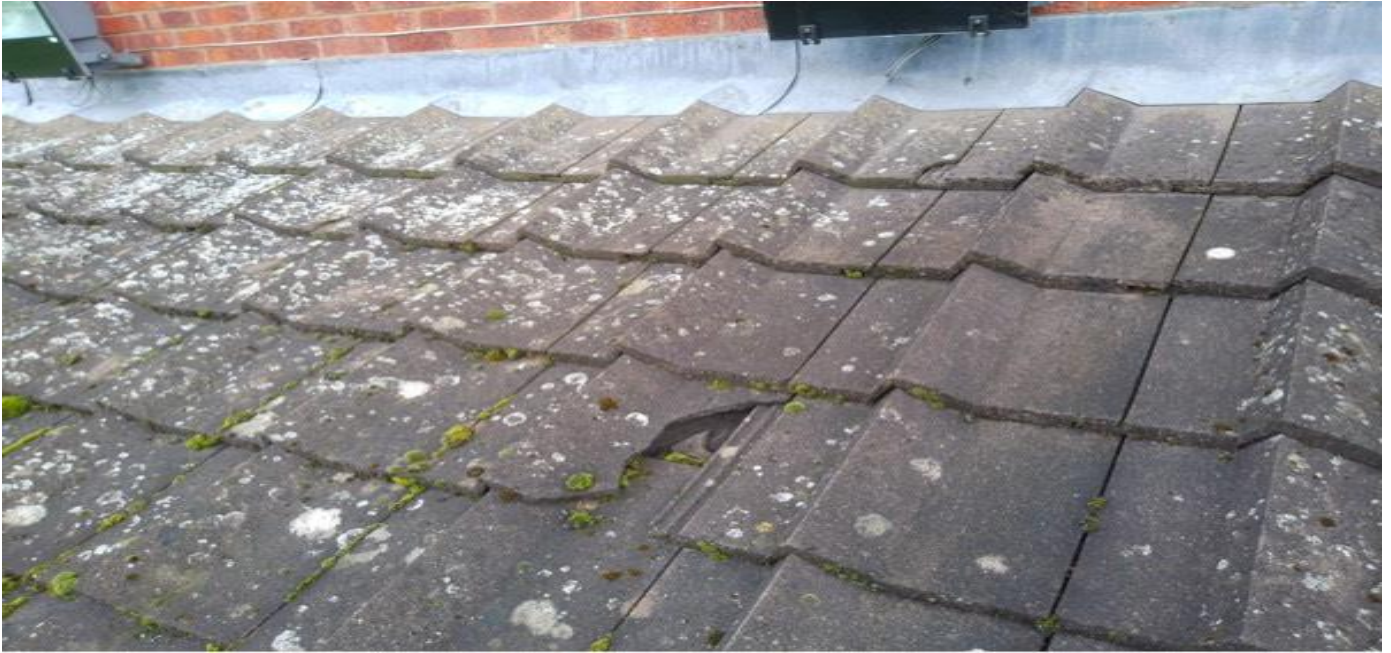
## Broken tiles

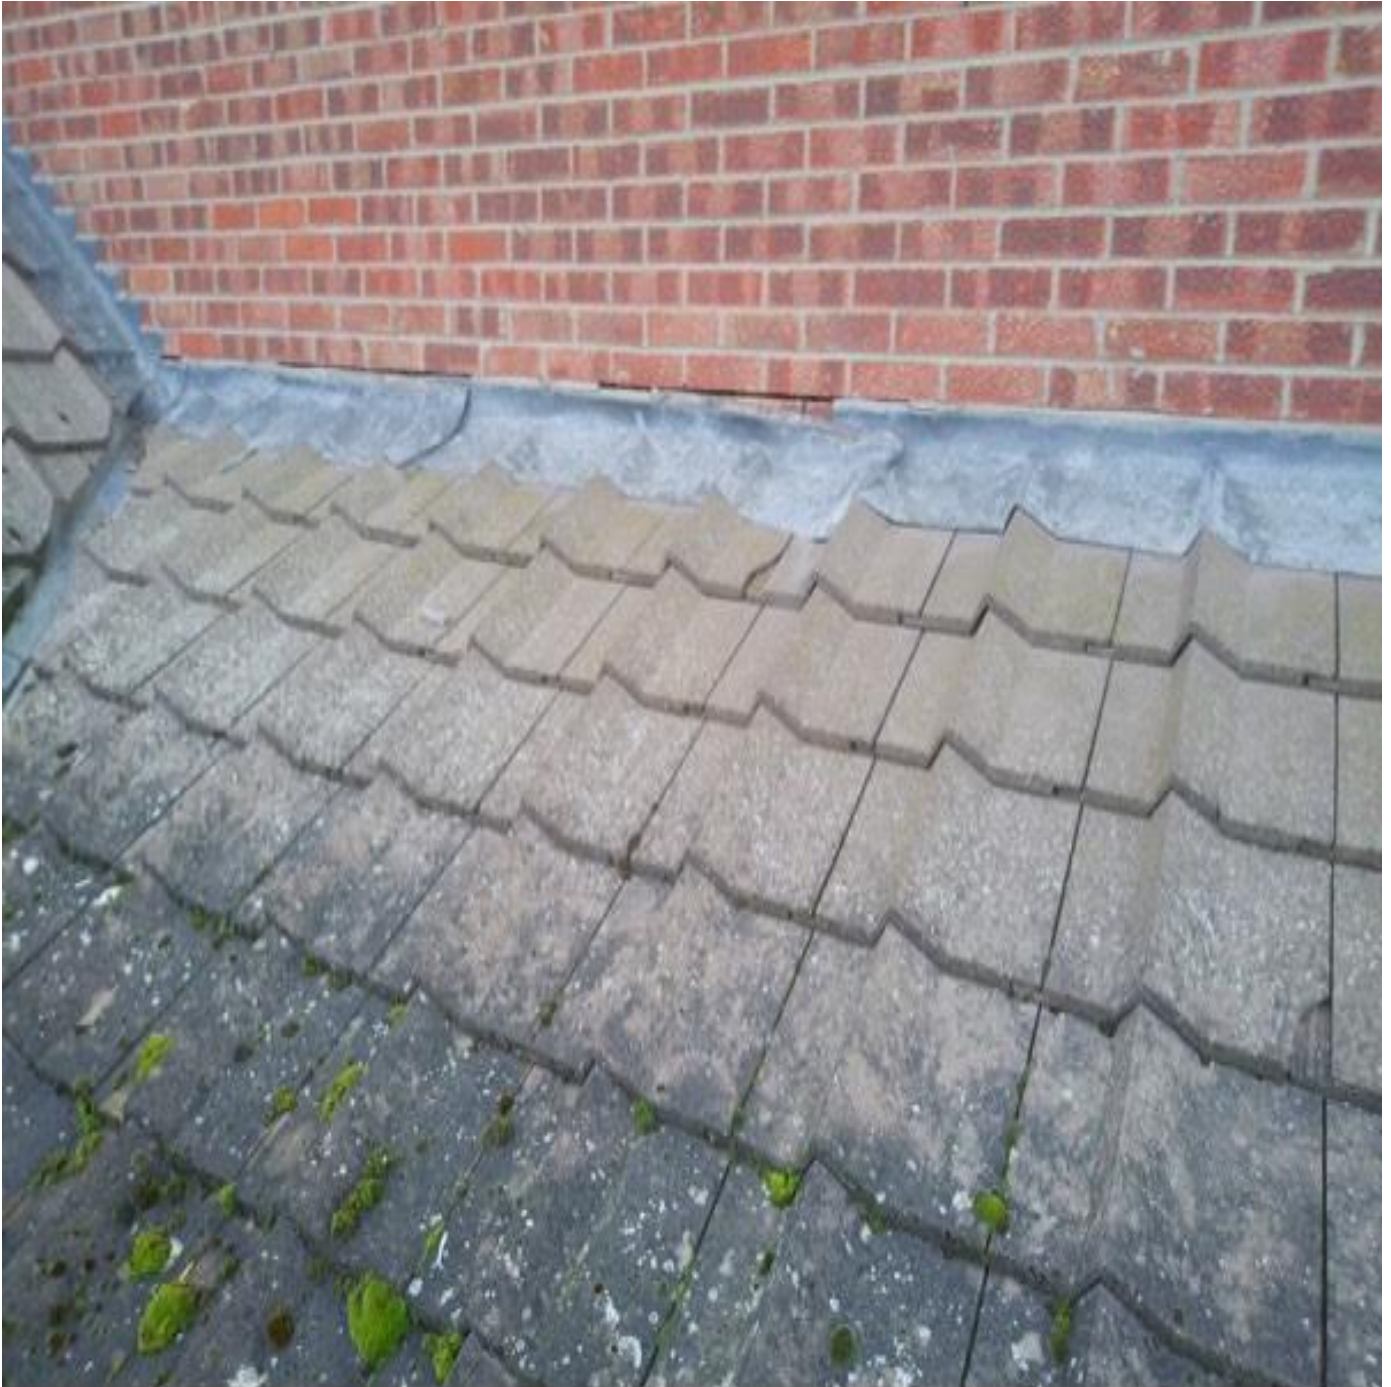
## Lead flashing at roof perimeter

- This large porch structure which covers the main entrance area (located at the rear elevation) has failed lead flashings due to pointing disrepair at the adjoining wall surfaces and a number of broken tiles are present.

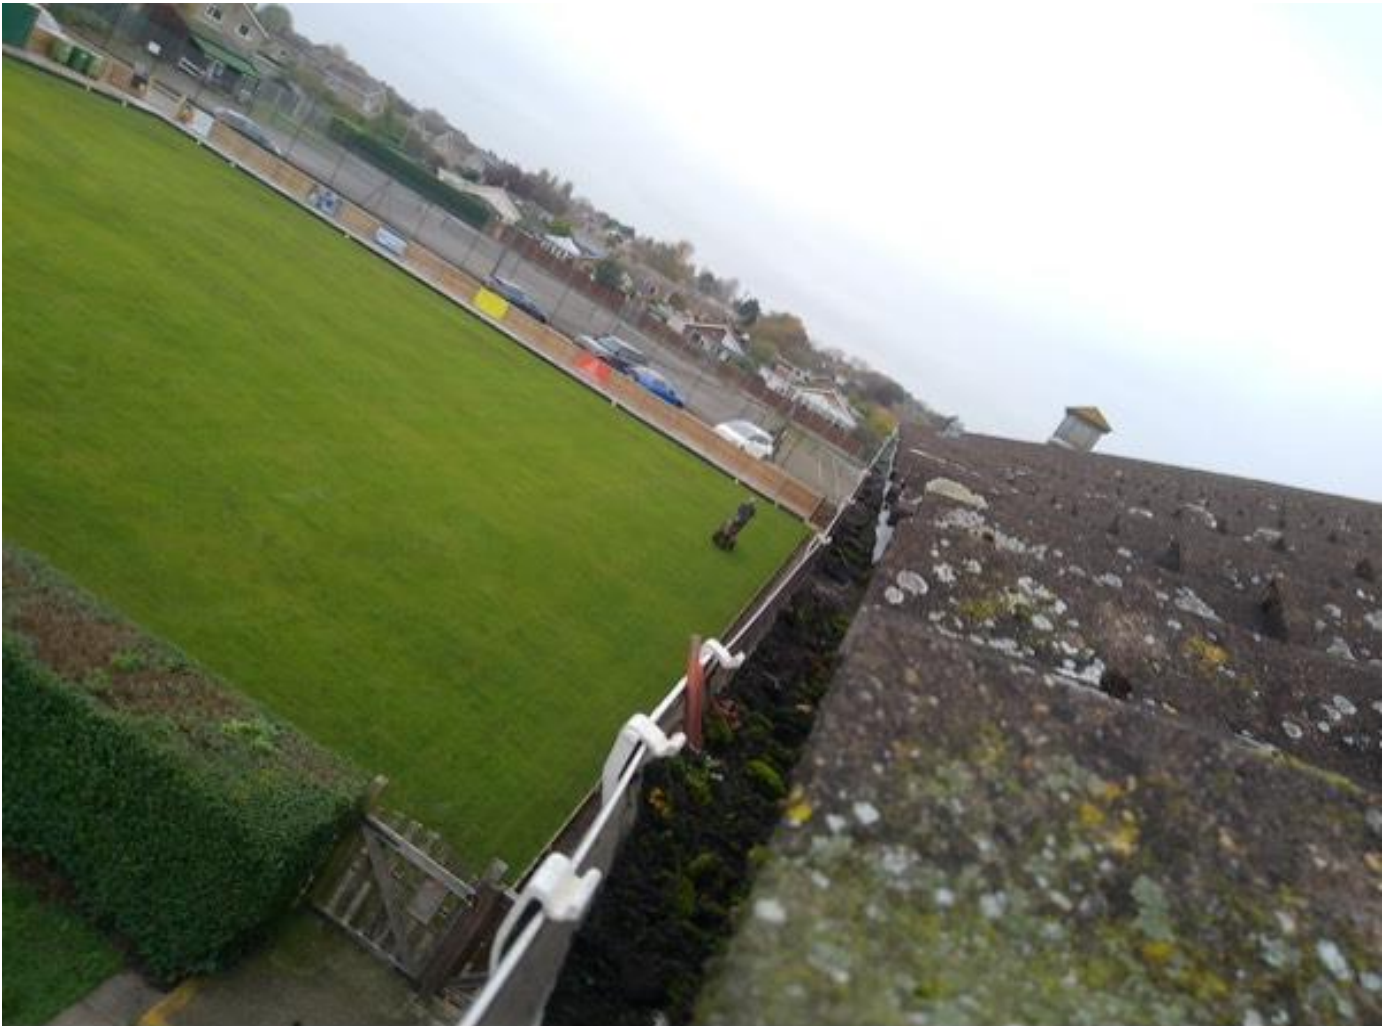
## Front gutter

- Water is discharged from the roof via a PVCU gutter section rainwater system with outlet downpipes hold fast fixed to the external elevations.
- The gutter section rainwater system shows physical evidence of blockages with debris causing restrictions to the water flow leading to the rainwater outlets.
- Recommend these are cleared and repaired to prevent water penetration to the building.

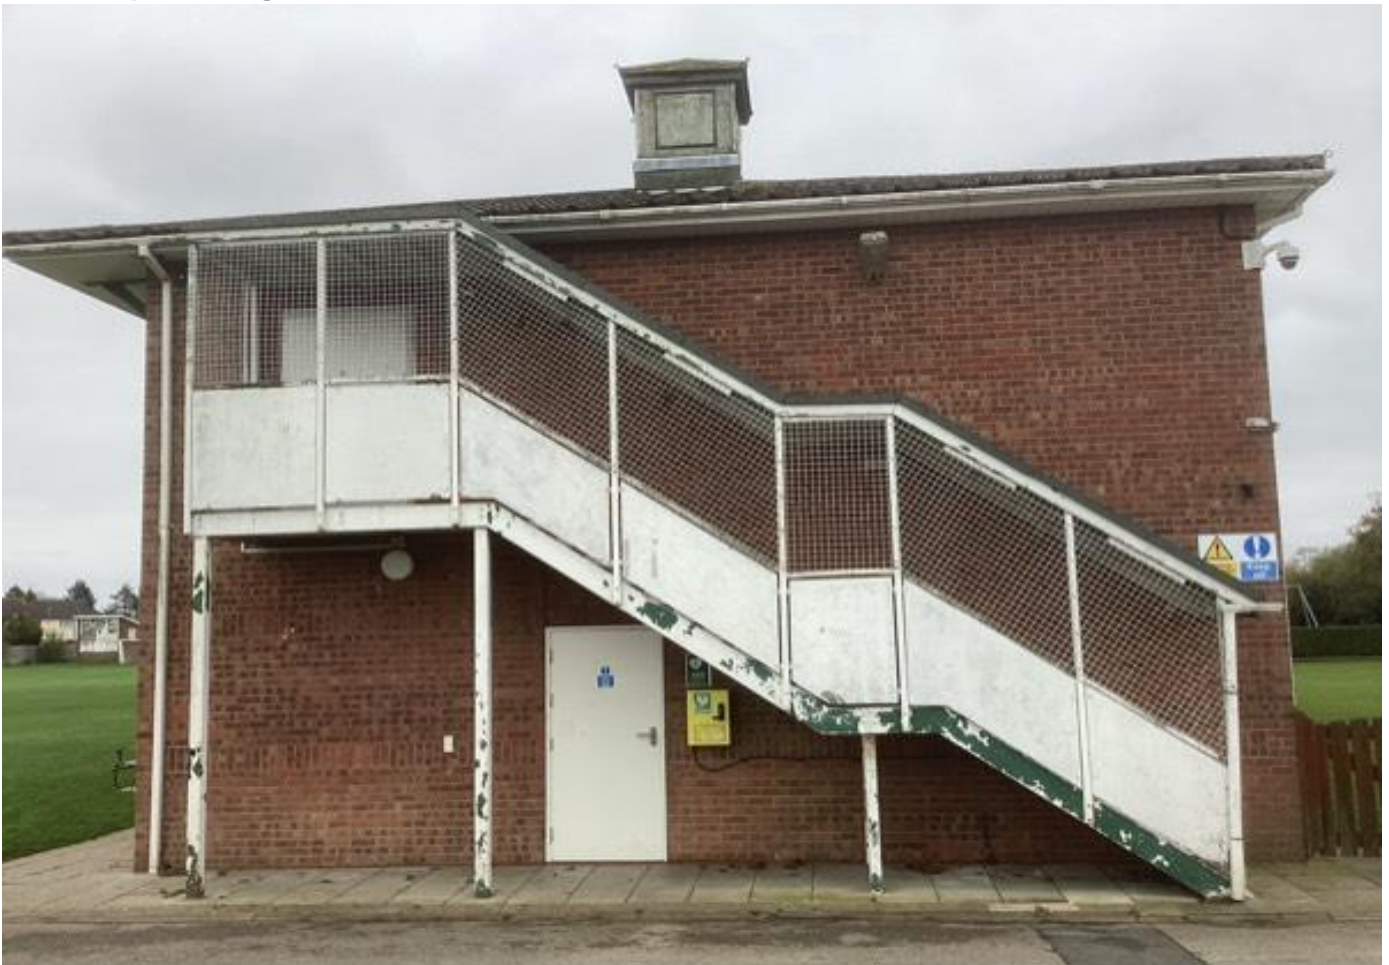
### Fire escape at left gable

- The mineral felt roof surface above the left-hand fire escape is severely degraded, failure of this roof surface can result in failure of the timber structure above the staircase, which could become a risk to users.

- Recommend the roof structure and surface be repaired or replaced as necessary after further investigation.
- The fire escape staircase at the right-hand gable is a fabricated steel framework with vertical supports and fixings locating the framework to the gable wall of the building.

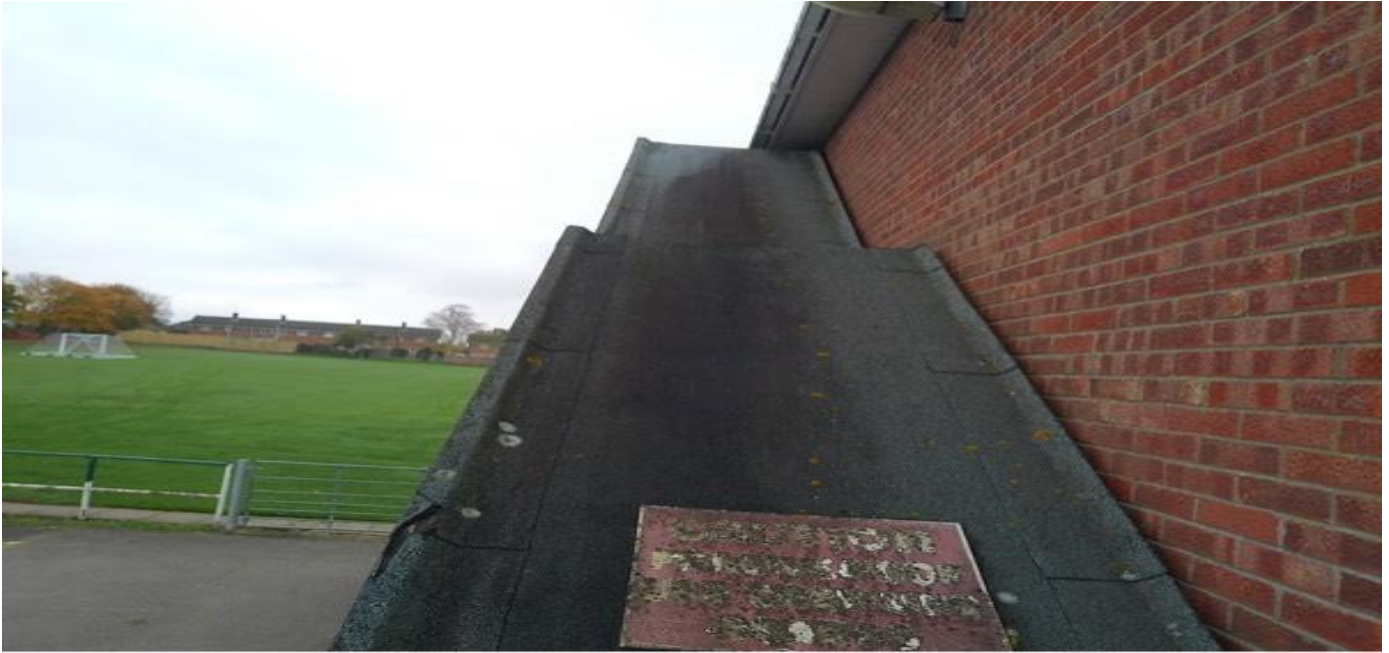
## Mineral felt roof surface above staircase

- The left hand staircase is less affected, however the roof installed above this is worn and the surface covering and decking material should be replaced.

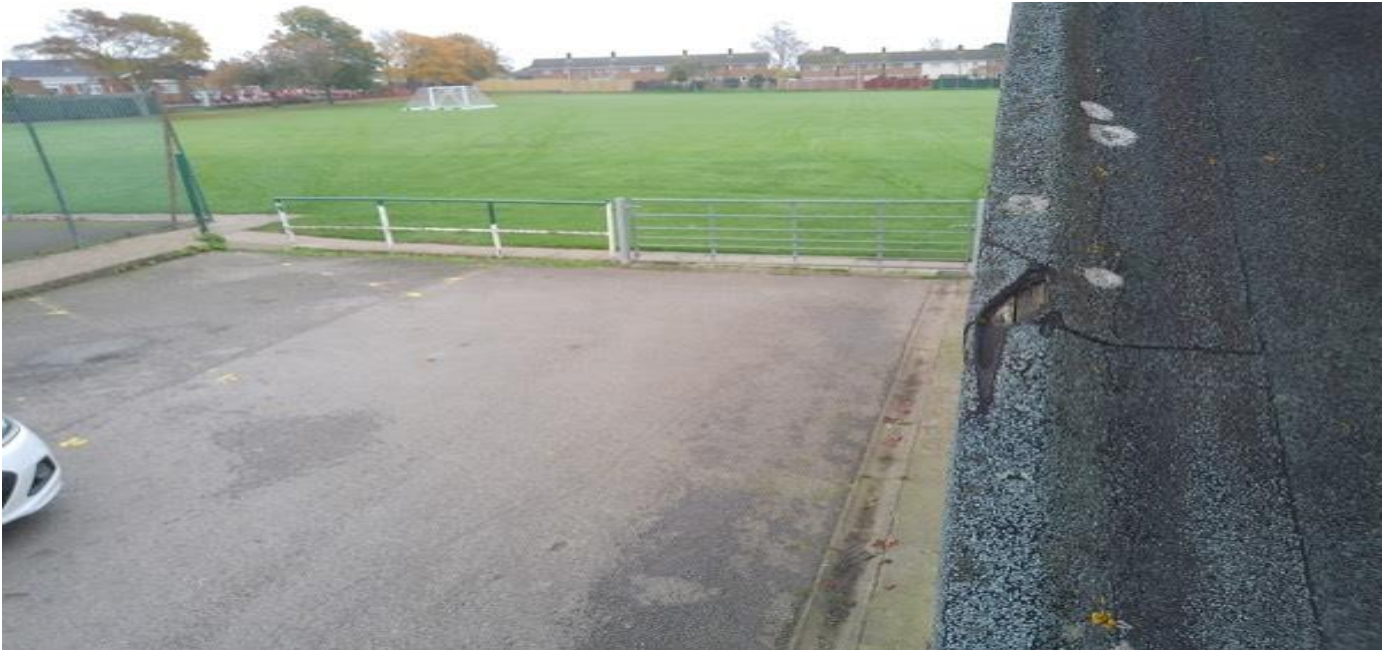
## Staircase roof surface is degraded and requires replacement

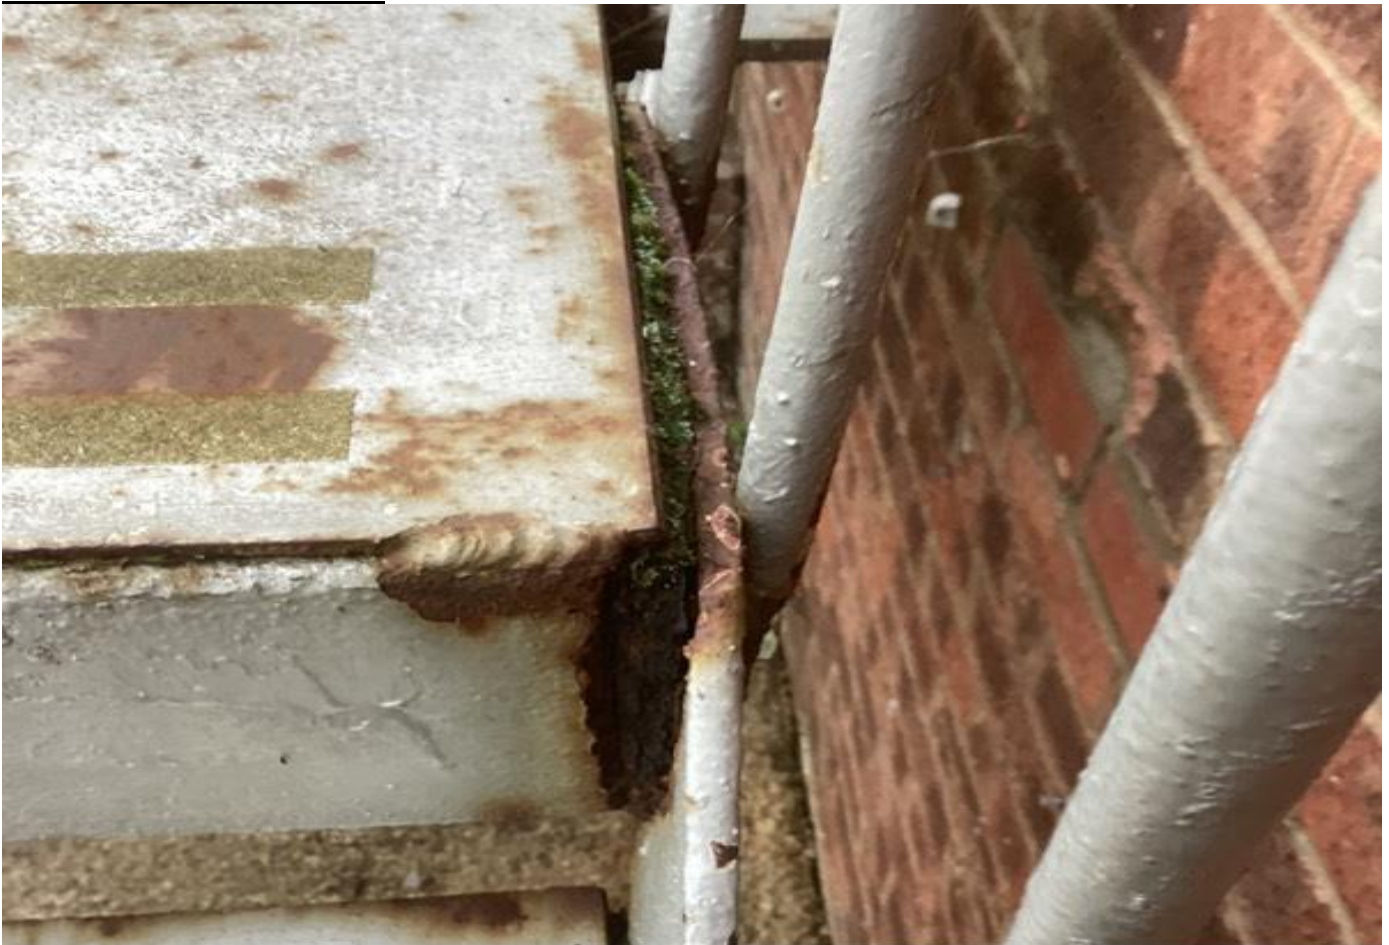
- The fire escape staircase at the right-hand gable is a fabricated steel framework with vertical supports and fixings locating the framework to the gable wall of the building. The steel treads are bolted in place with welded and bolted handrails and supports.
- The steel framework is degraded, due to lack of maintenance and failed painted surfaces which has led to rusting and expansion of the steel framework.
- Whilst the structure is still considered relatively sound and useable, this is considered as a vital part of the buildings safety framework, and it should be considered for replacement to ensure it is safe for future use and a low liability risk should persons use this without permission.

## Steel framework is rotted

- This is considered as a vital part of the buildings safety framework, and it should be considered for replacement to ensure it is safe for future use and a low liability risk should persons use this without permission.

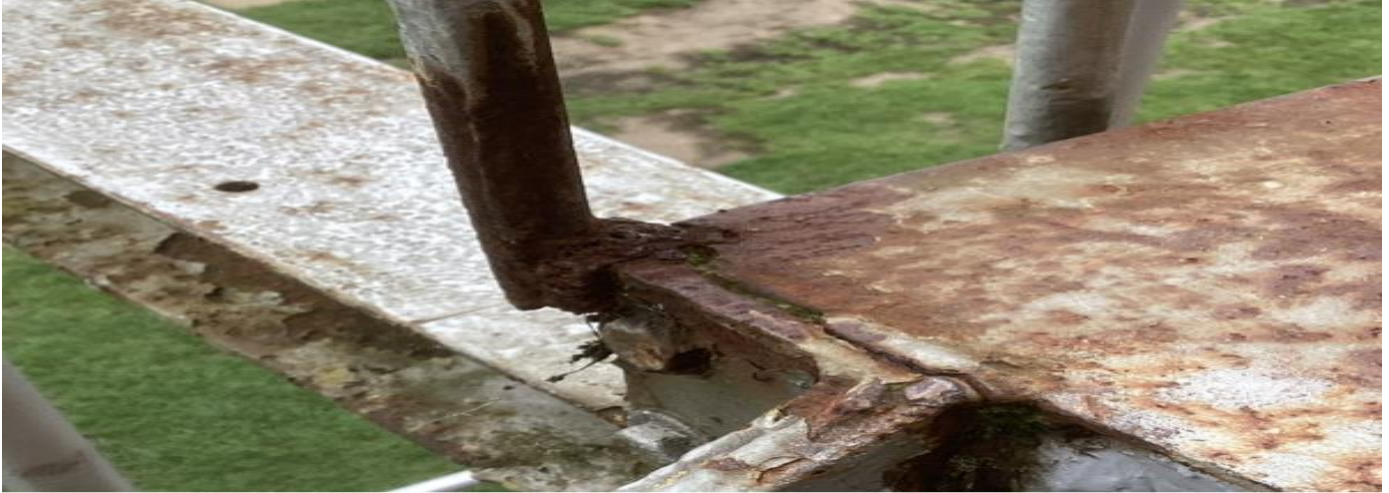
## Failed welding at railings

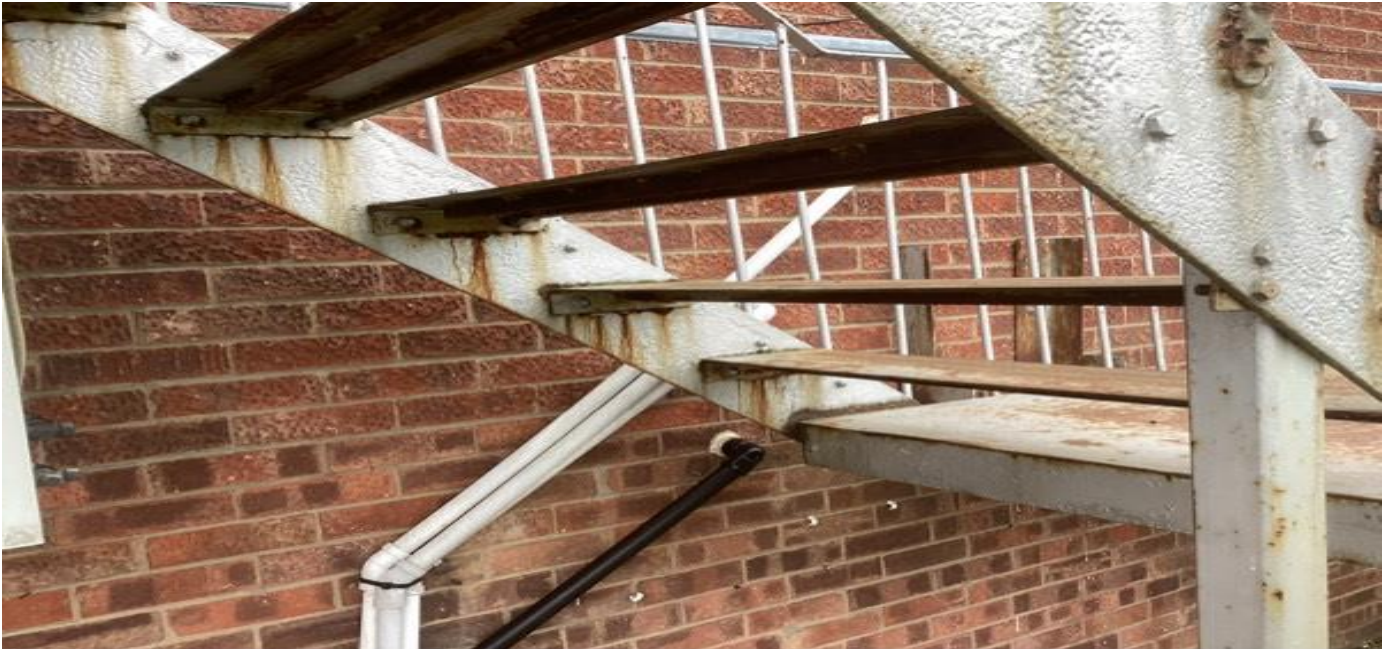
## Rusted steelwork at staircase framework and treads

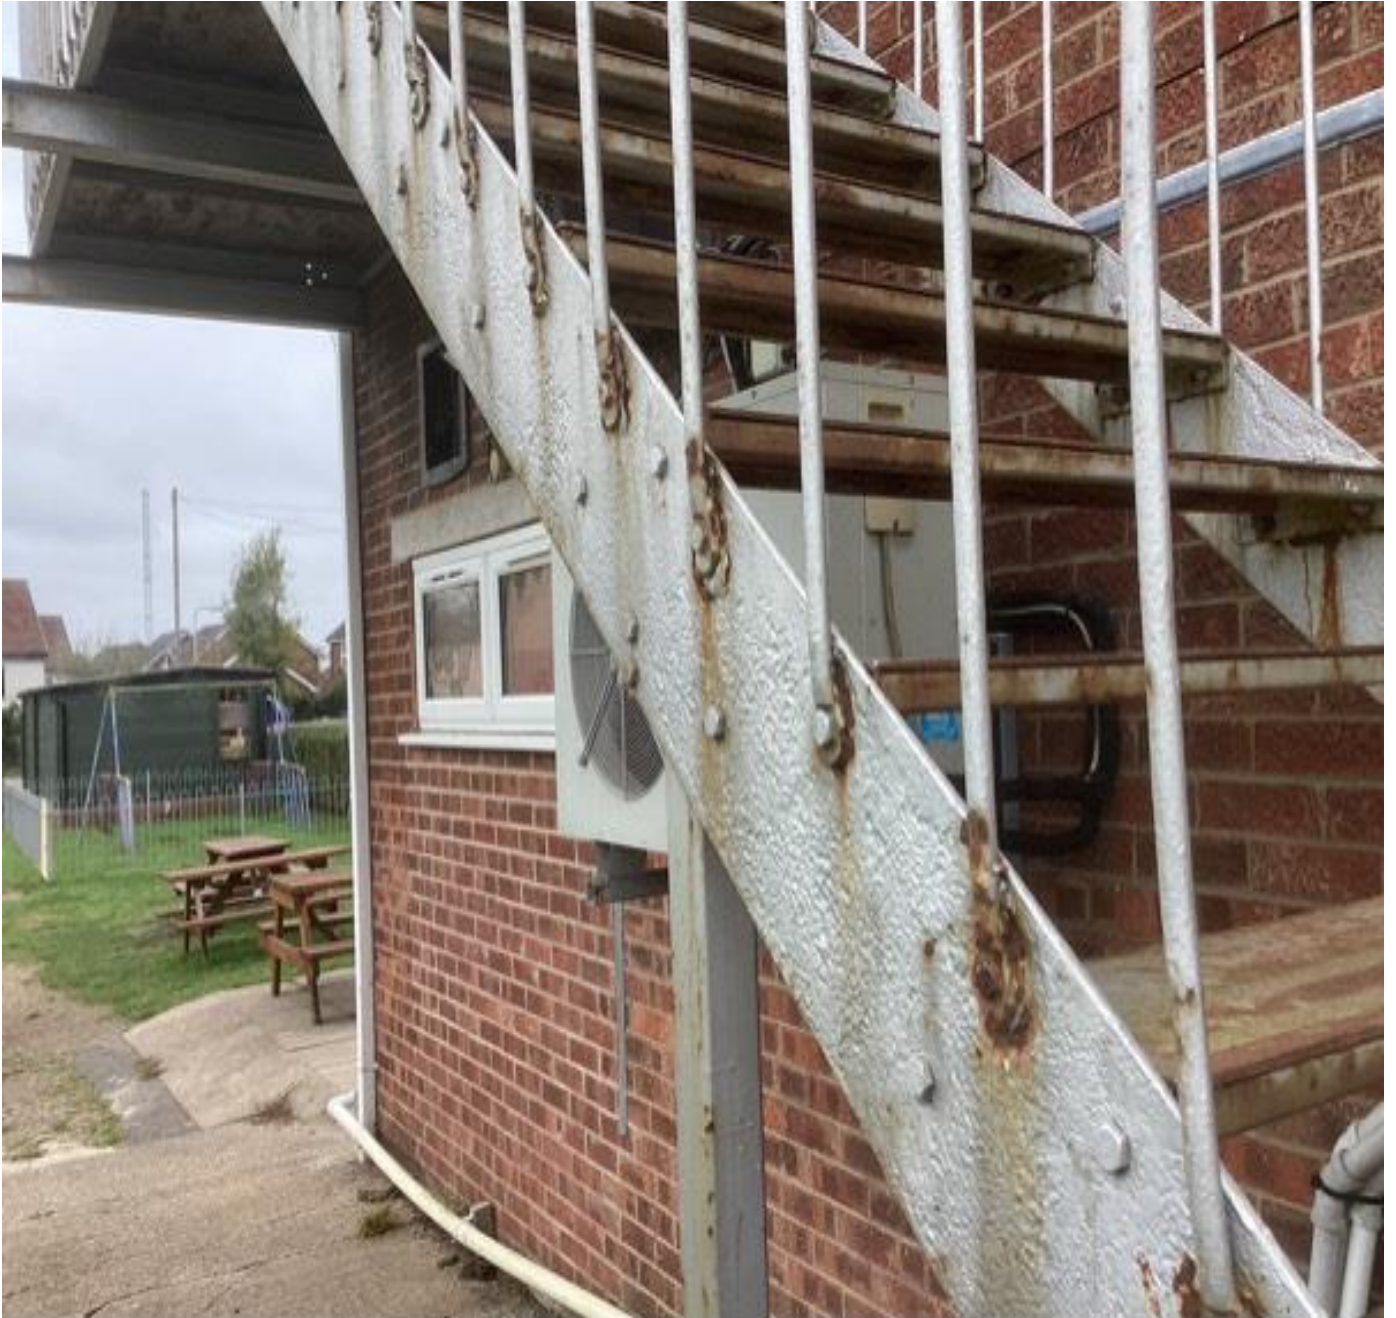
- These steel frame structures located at the gable ends of the building are constantly exposed to weather and as such, the structures and surfaces are degraded. The right hand (north facing) staircase has been severely degraded, and Rust is present to the railings which support handrails, treads, structural joints and main framework to an extent that these should be considered a hazard.
- Whilst the staircase is repairable, it is recommended that specialist contractors are appointed to assess for repair and if not reasonable, then replacement of the structure will be necessary.
- The left-hand staircase is less affected, however the roof installed above this is worn and the surface covering and decking material should be replaced.

## Frame is rusting and weathered

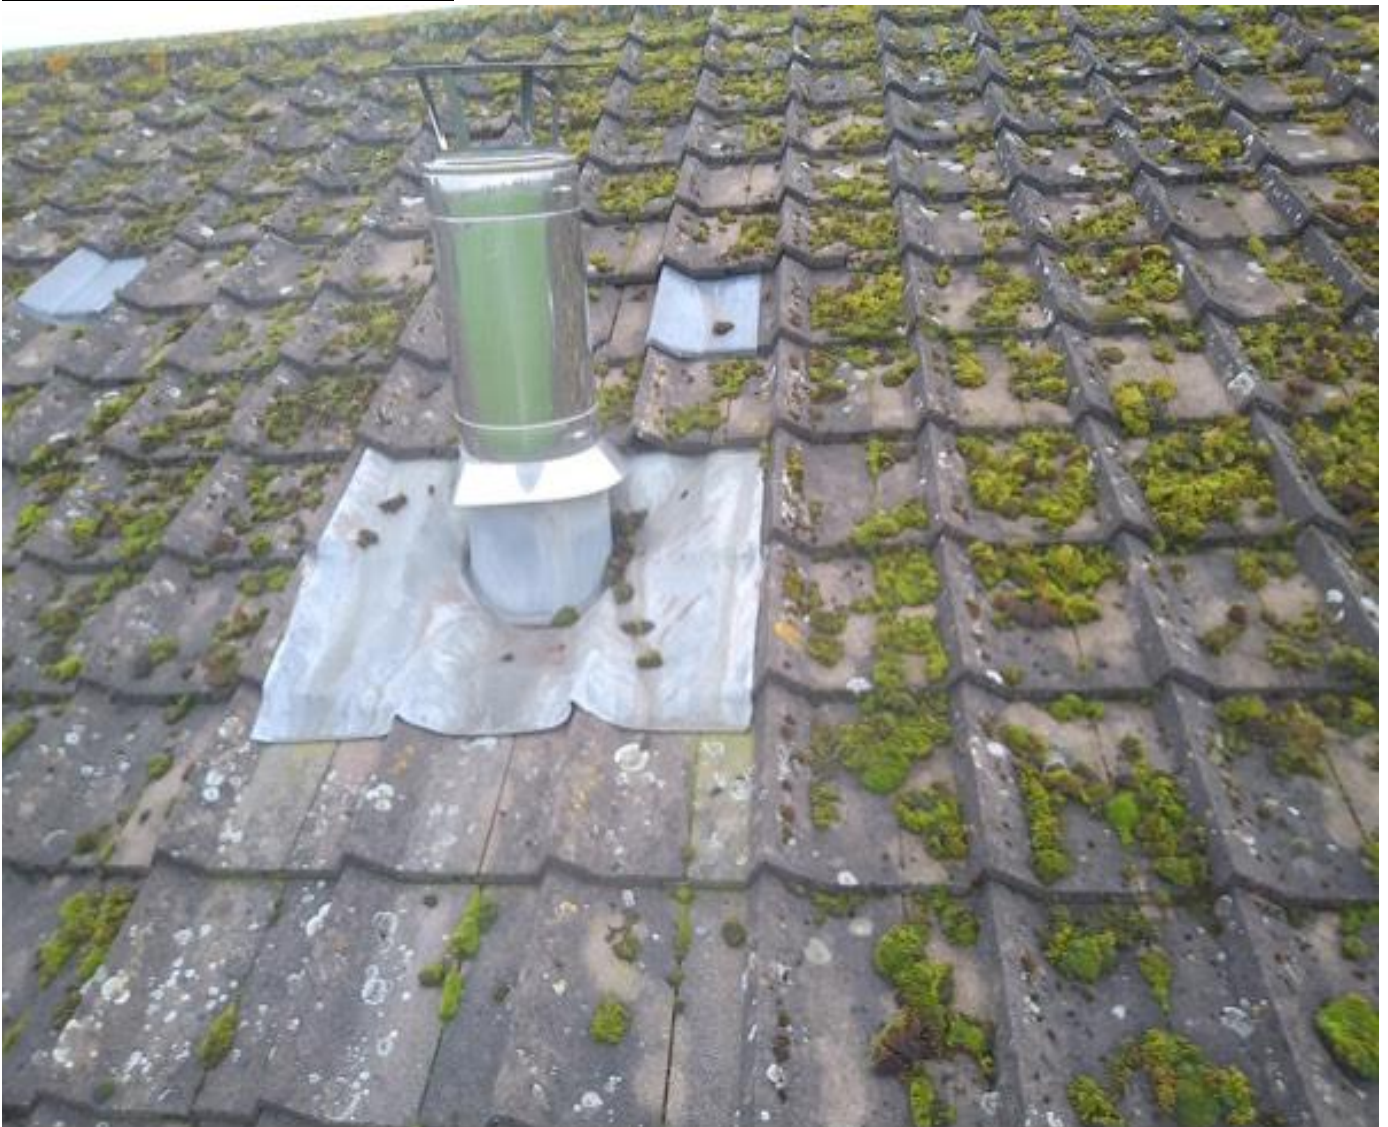
- The disused flue pipe from the former boiler system is an ingress risk into the roof and ceiling areas of the property, recommend this is removed and the roof surface retiled.

### Disused flue should be removed

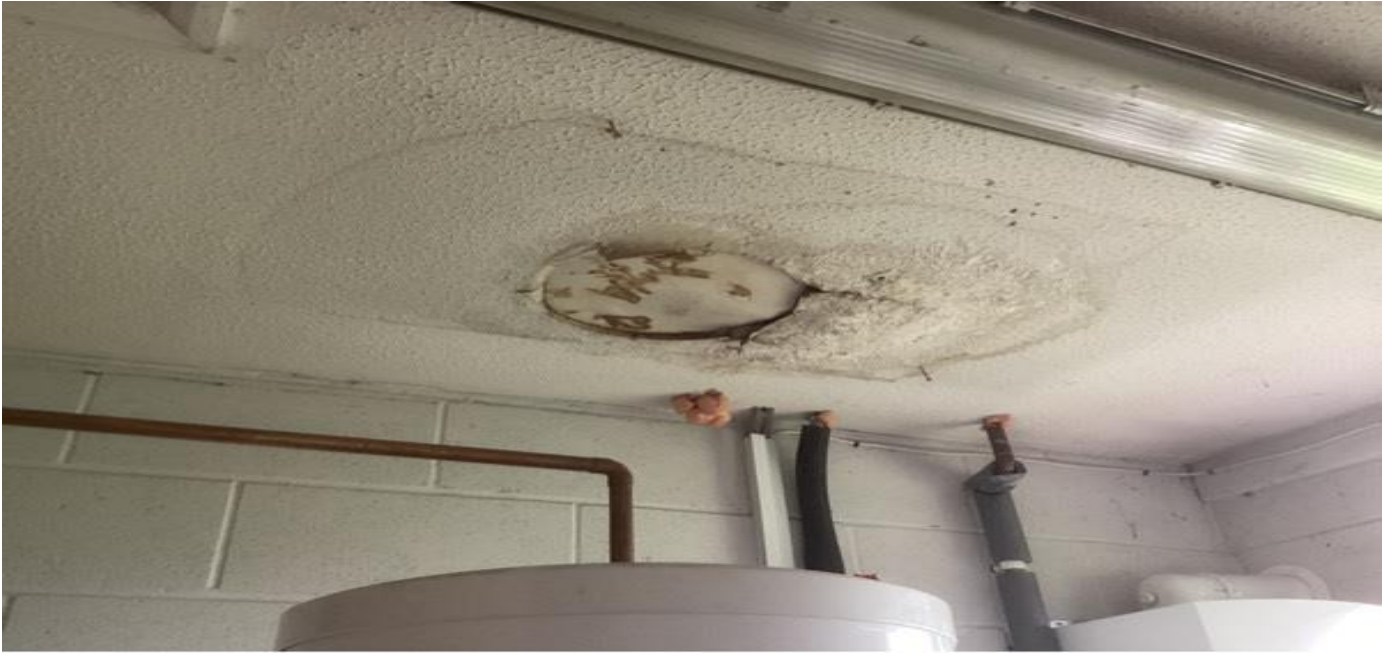
- The internal ceilings have a plaster decoration finish with evidence of water stain marks within the boiler room, ingress due to disused boiler flue. Other internal ceiling surfaces had low proto-meter moisture readings detected which would suggest no problems with leaks to the roof or walls in other areas.

## Water ingress has damaged ceiling

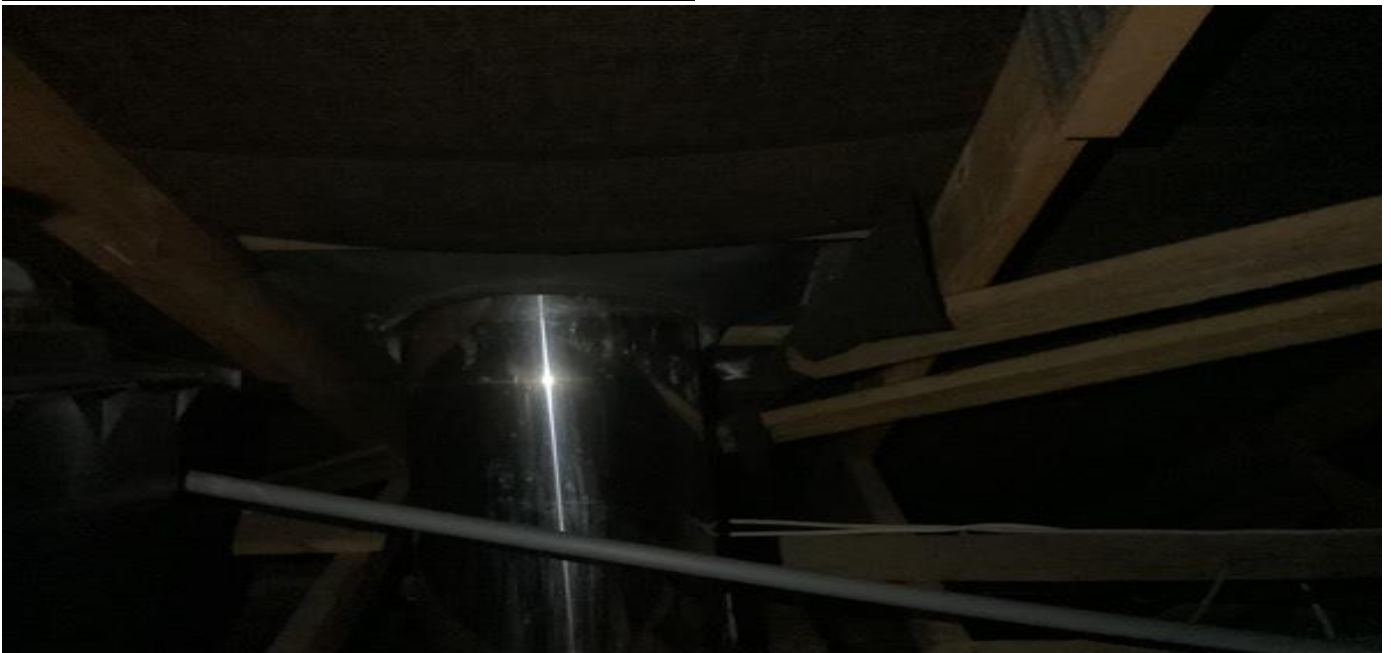
## Flue pipe through roof surface to interior loft area
