# Building Survey

**Client Name:** Saxilby Community Parish Council  
**Address:** St. Andrews Community Centre  
William Street  
Saxilby  
Lincolnshire  
LN1 2LP  
**Purpose of Report:** STRUCTURAL BUILDING SURVEY  
**Report Reference:** SBS|MLH|2024  
**Inspection Date:** 30 Oct 2024  
**Surveyor Name:** C McLean BSc Hons, MCIQB, CSRT, CSSW, DipDEA, UKAS-P402/P405  
**Building Surveyor Engineer Name:** Greg Owen BSc (Hons) C Build E, MCABE.

**Type of property:** Community centre

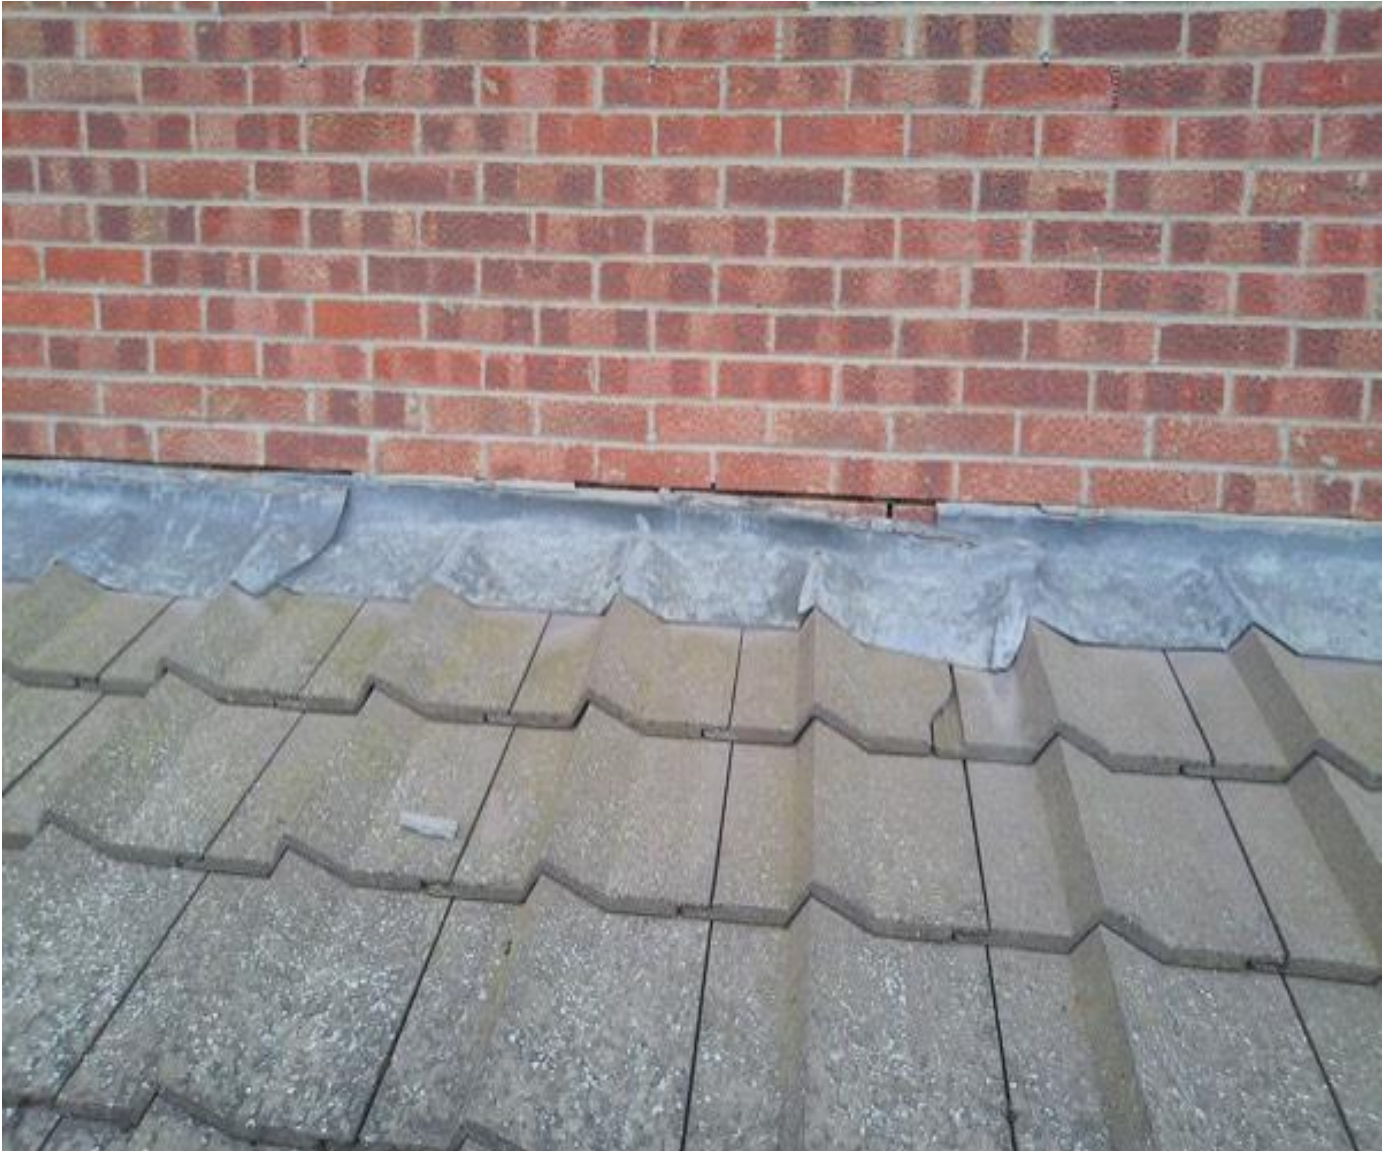
- There are a number of defects at the entrance area roof which covers the access at the rear elevation, the lead flashing fitted to the building elevation is loose in a number of areas due to failed pointing, and there are broken roof tiles on the roof surface.

### Failed pointing at lead flashing

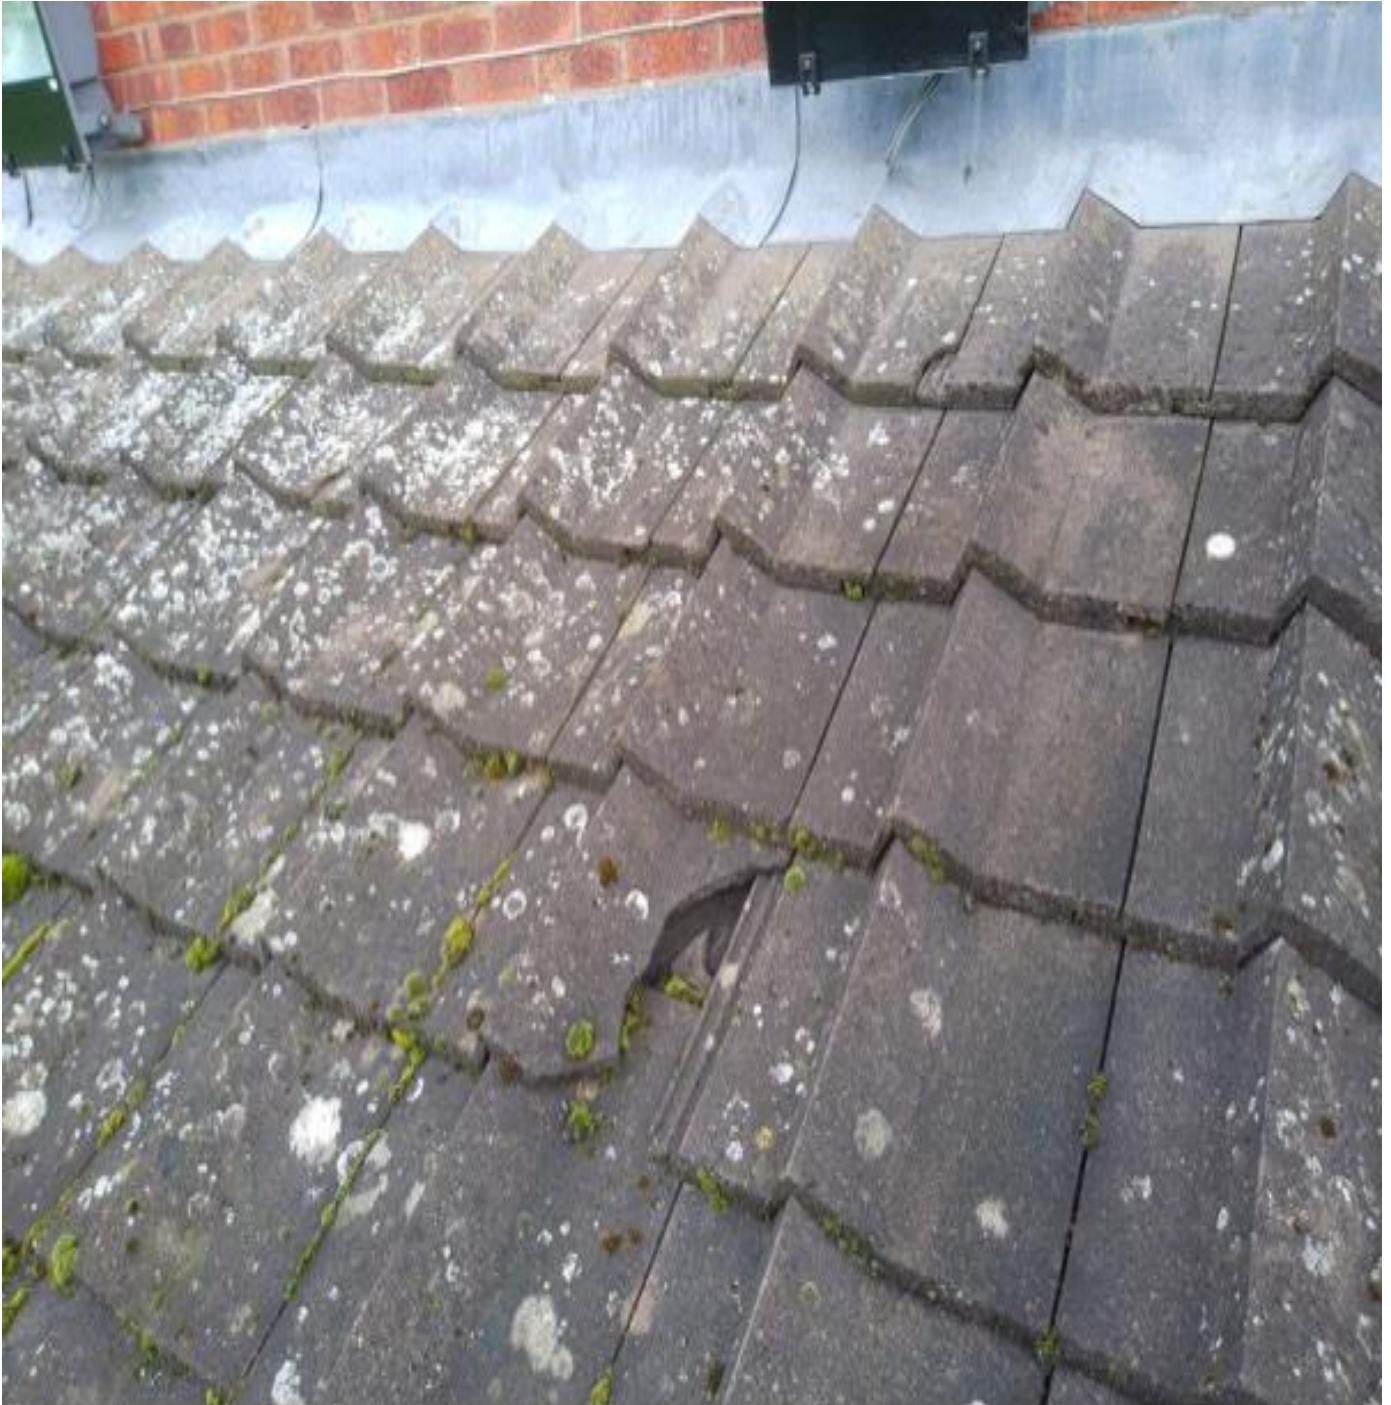
## Broken tiles on roof surface

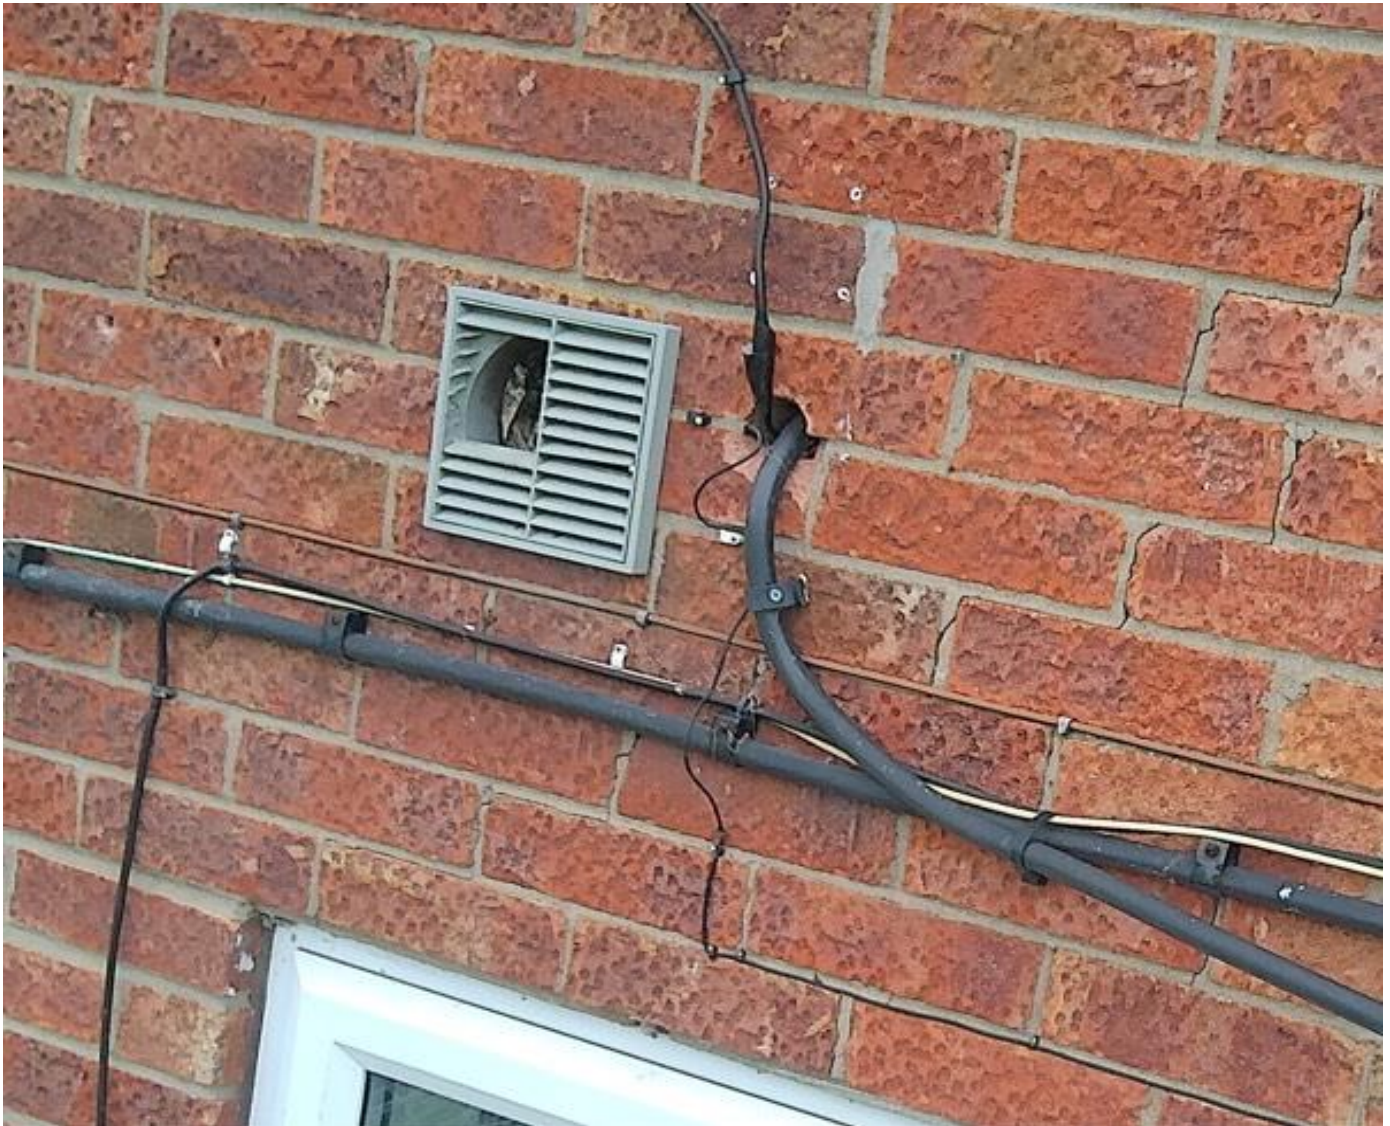
**Open and damaged ventilation covers, holed brickwork should be sealed around pipes and cables.**

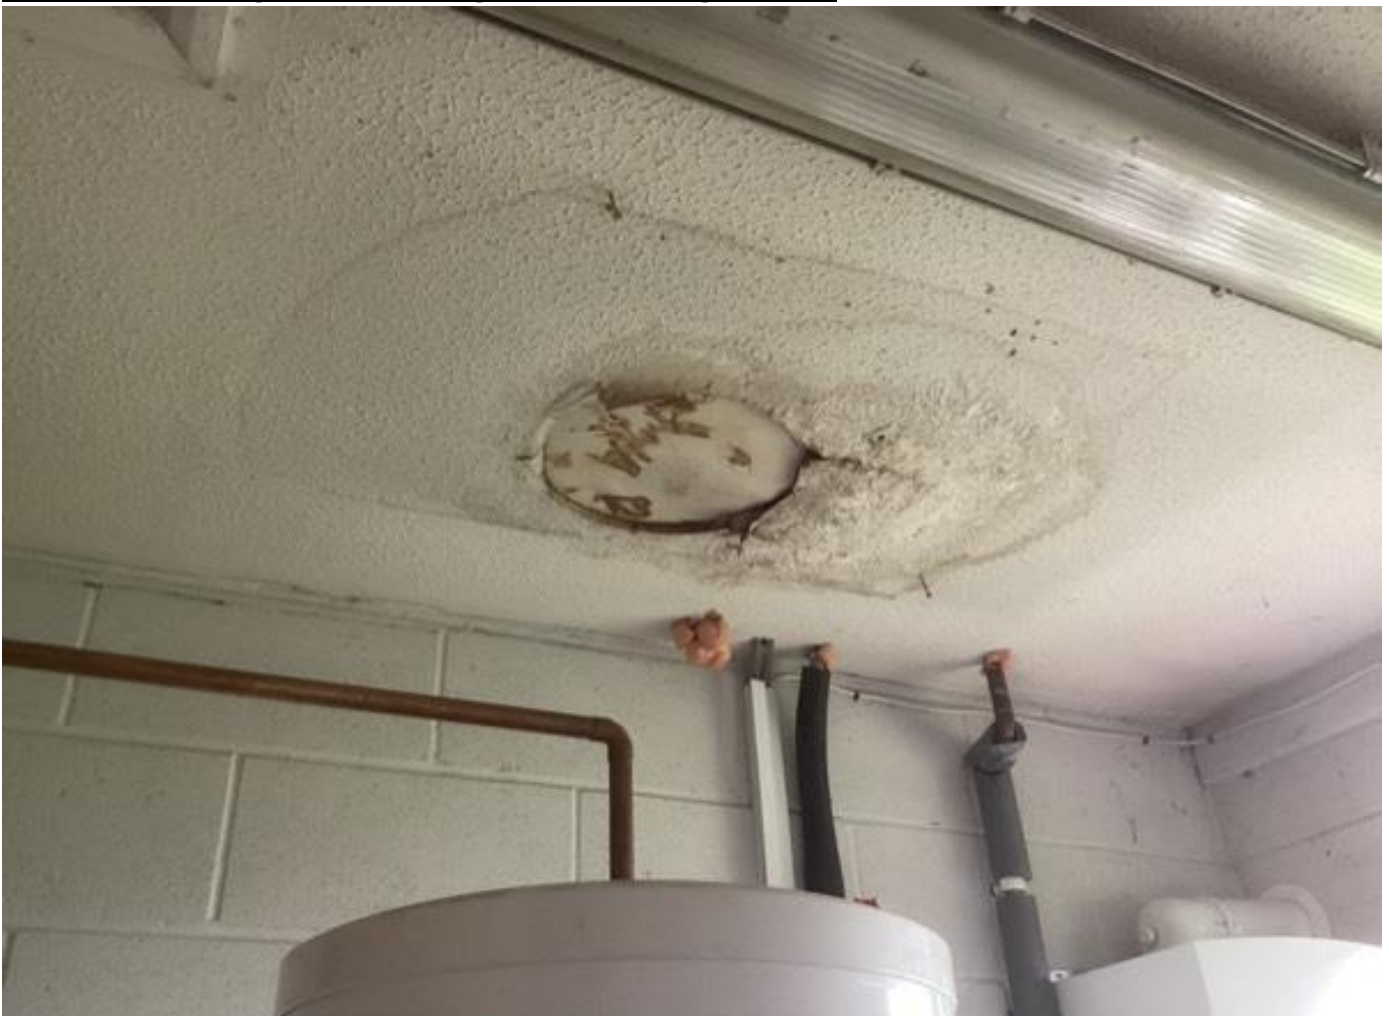
### Boiler room ceiling is water damaged. Artex ceiling surface.

- ACM testing would confirm positive or negative content.
- As per CAR2012 regulations, testing of the suspect material is recommended prior to any works being carried out to confirm or refute the presence of an ACM's.
