# Building Survey

**Client Name:** Saxilby Community Parish Council  
**Address:** St. Andrews Community Centre  
William Street  
Saxilby  
Lincolnshire  
LN1 2LP  
**Purpose of Report:** STRUCTURAL BUILDING SURVEY  
**Report Reference:** SBS|MLH|2024  
**Inspection Date:** 30 Oct 2024  
**Surveyor Name:** C McLean BSc Hons, MCIQB, CSRT, CSSW, DipDEA, UKAS-P402/P405  
**Building Surveyor Engineer Name:** Greg Owen BSc (Hons) C Build E, MCABE.

**Type of property:** Community centre

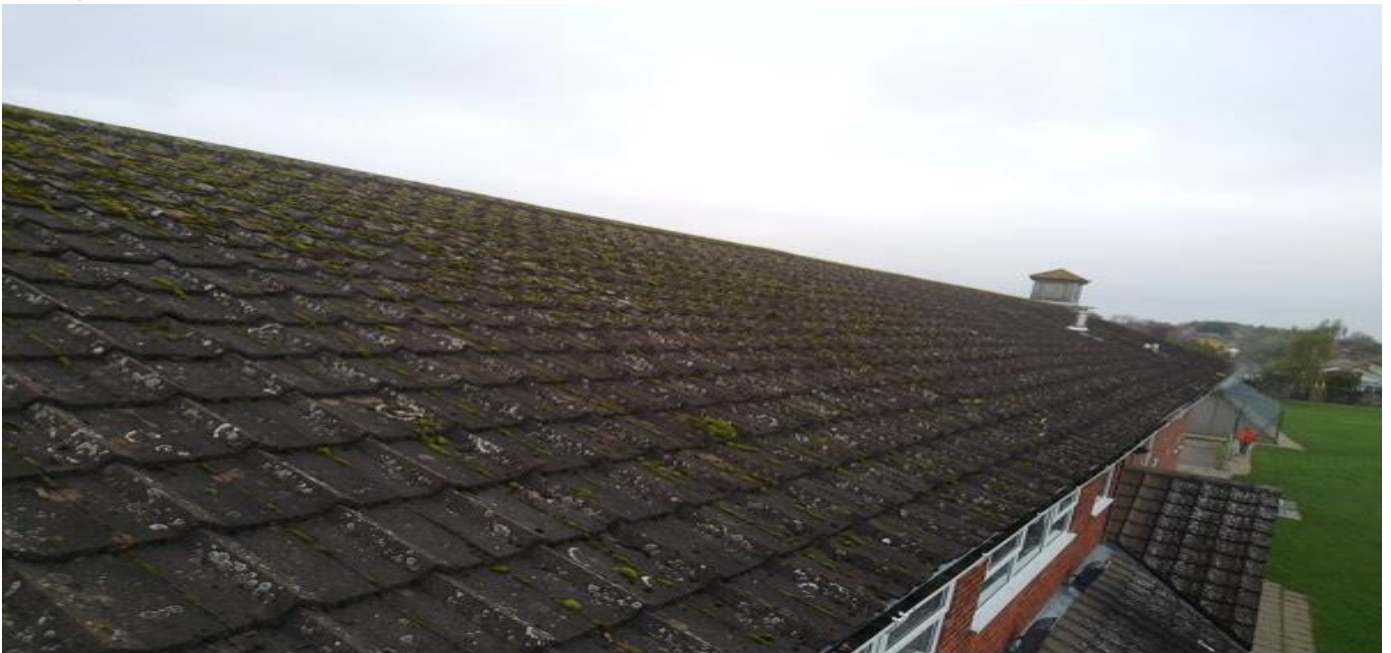
## Rear pitch

- The property has a pitched tile roof (Concrete tiles) this appears to be in good condition but requires maintenance to the mortar areas.
- The mortar verges require maintenance where cracking/missing mortar is evident and common problem with exposed gable edges.

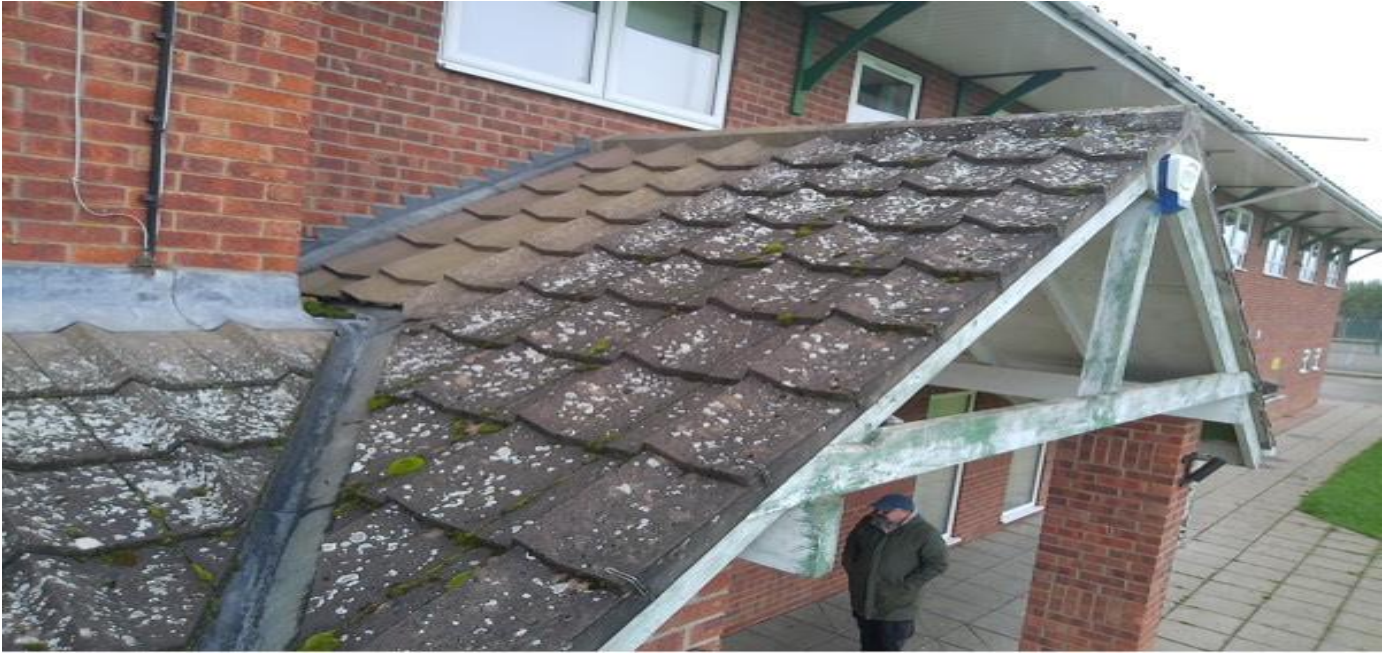
**Porch area central to roof**

- The main entrance has a pitched tile roof (Concrete tiles) this appears to be in good condition generally but does have a small number of broken tiles and failed lead flashing at the boundary with the main elevation and the valley areas require maintenance.

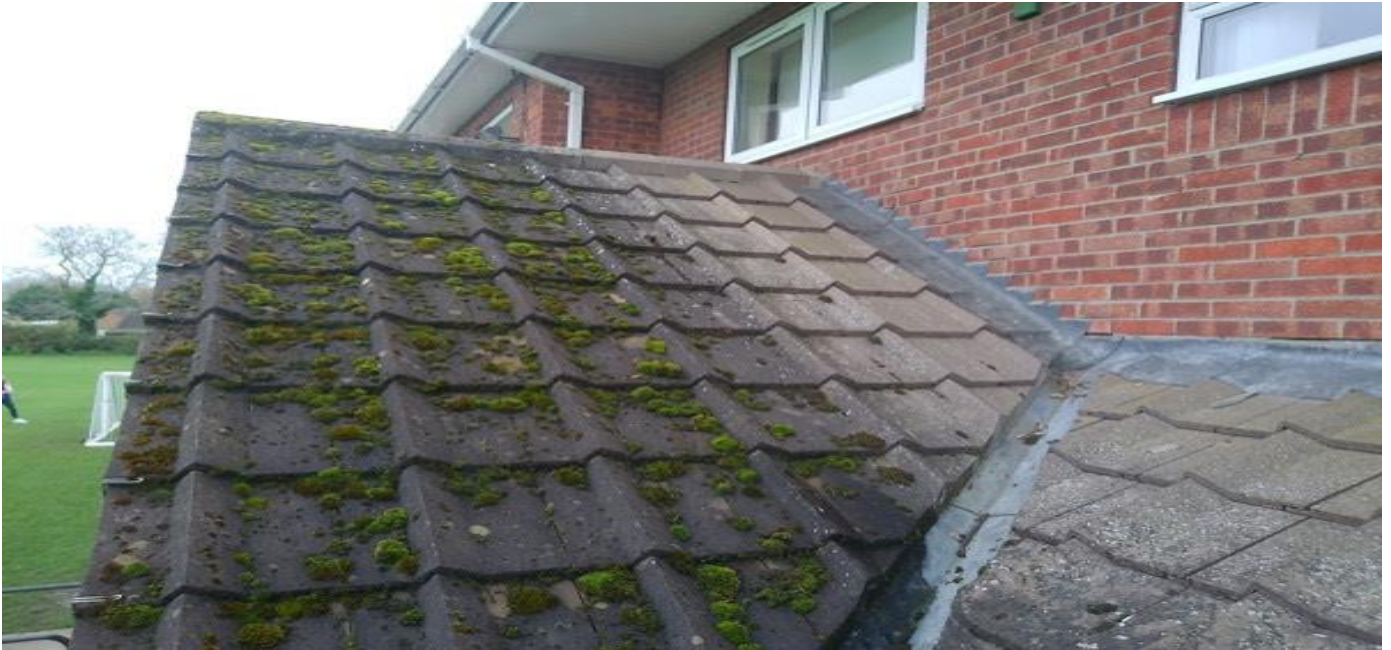
**Porch roof area**

- There are a number of defects at the entrance area roof which covers the access at the rear elevation, the lead flashing fitted to the building elevation is loose in a number of areas due to failed pointing, and there are broken roof tiles on the roof surface.

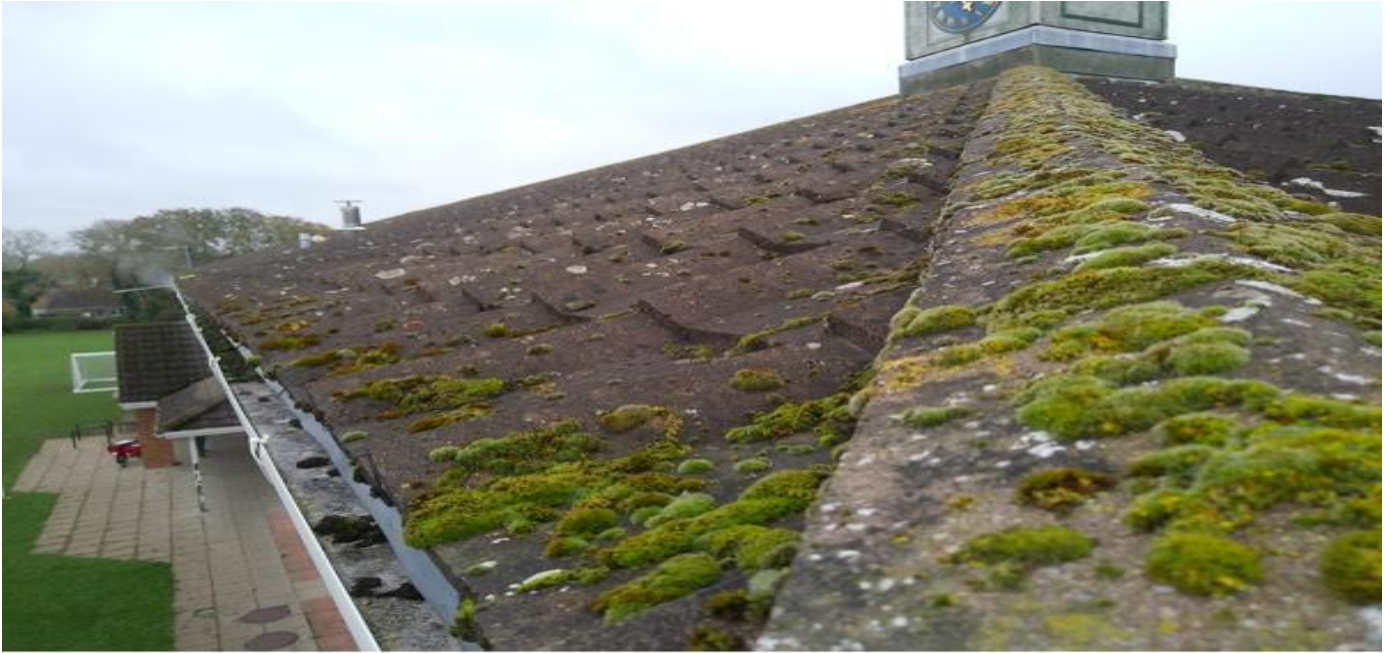
## Rear gutter

- Water is discharged from the roof via a PVCU gutter section rainwater system with outlet downpipes hold fast fixed to the external elevations.
- The gutter section rainwater system shows physical evidence of blockages with debris causing restrictions to the water flow leading to the rainwater outlets.
- Recommend these are cleared and repaired to prevent water penetration to the building.
